Engineering Failure Analysis

The Conclusion from One Million Tonnes of Experience in Galvanizing Steel – LMAC is not a Primary Instigator of Cracking

Keywords: Galvanizing; structural steelwork; cracking; industrial experience.

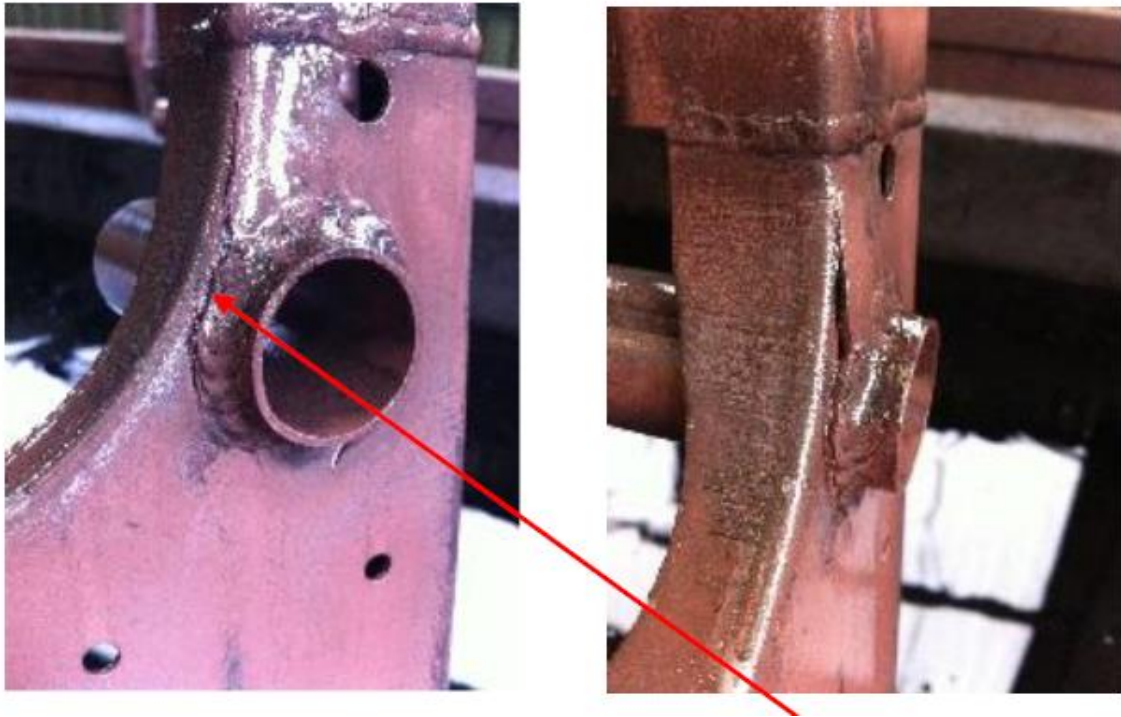
The types of crack identified as existing after fabrication were usually related to detail types with known susceptibility to cracking, and can hence usually be ascribed to sub-optimum design. Figure 2 shows one example of such cracking associated with a tubular insert in a hollow section, where the weld run is too close to the edge of the component and the welding-induced residual stresses have combined with those existing from the fabrication at the corner of the hollow section to initiate cracking. Figure 3 shows another example of cracking that occurred during fabrication arising from the superposition of welding residual stress and hardness gradients with other pre-existing fabrication stresses. Figure 4 shows cracking observed in steel checker or tread plate, which is more susceptible to cracking during bending than a plane component because of the raised tear drop shapes. If the usual minimum bend radius is perhaps $1.5t$, where t is the plate thickness, then checker plate would require a larger inner radius of at least $3t$.

Figure 2 Weld run around an insert that was too close to an existing fabrication-induced region of plasticity/residual stress.

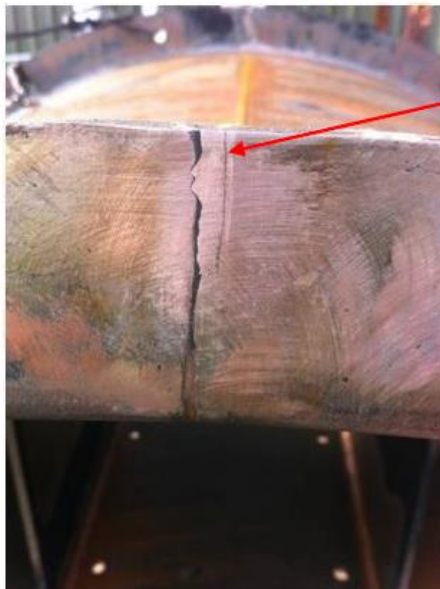
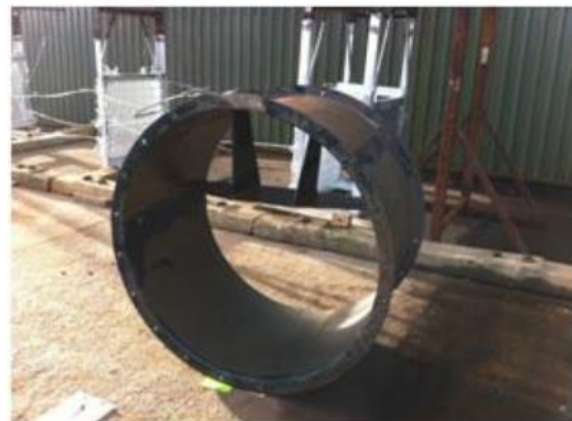
Small hairline crack in
flange of casing near weld

Figure 3 This crack is probably again due to a combination of the welding process (residual stress and hardness gradients) and the stresses induced during forming of the cylindrical casing.

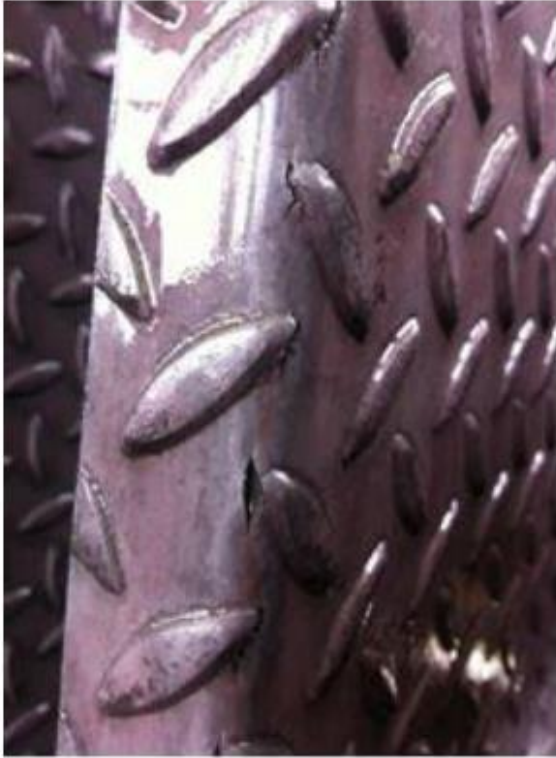
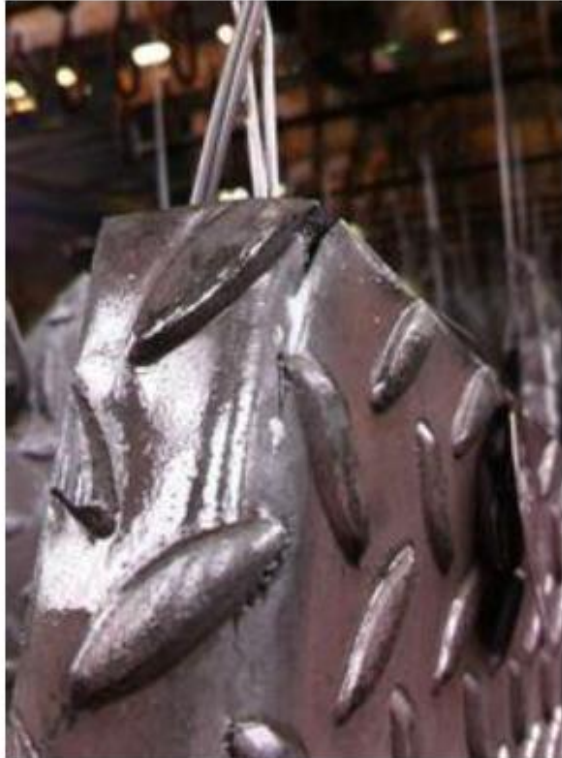
Figure 4 The cracking seen here is due to the steel checker plate having too tight a bend radius.

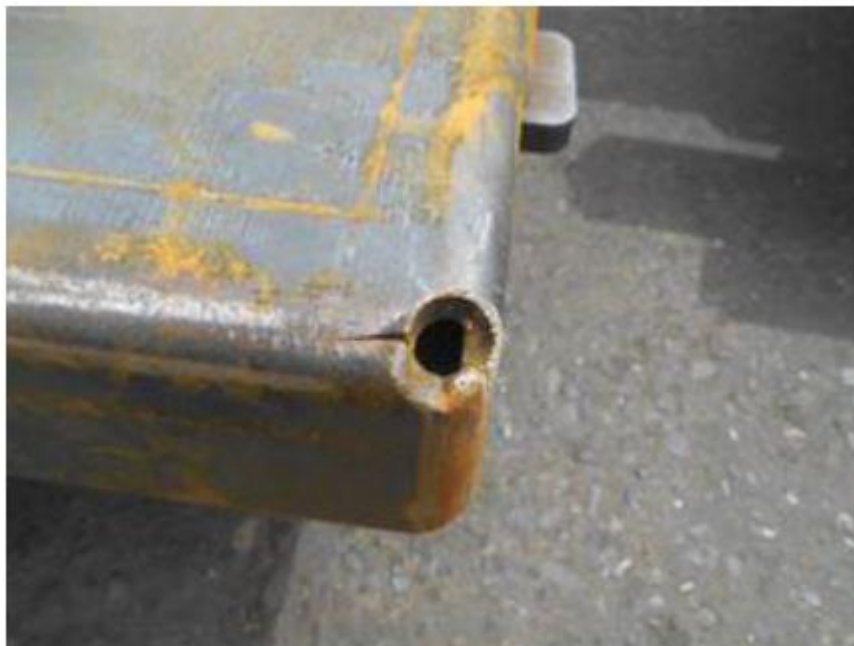
Figure 5 shows an interesting example of cracking that occurred during galvanizing and that is similar to a cope hole. A weld crack has initiated at a cut-out intended to avoid the defect-prone intersection of multiple welds. Cope holes and 'snipes', i.e. vent or drain holes and openings, are a common cause of cracking problems during fabrication and galvanizing and Figure 6 shows fabrication cracking induced at flame-cut snipe that was introduced to facilitate making a multipass weld. This crack would generally be ascribed to LMAC, rather than having its root cause as poor fabrication practice.

Figure 5 Weld cracking initiated from a small cut-out intended to avoid the problem of intersecting welds in fabrication of a hollow section.

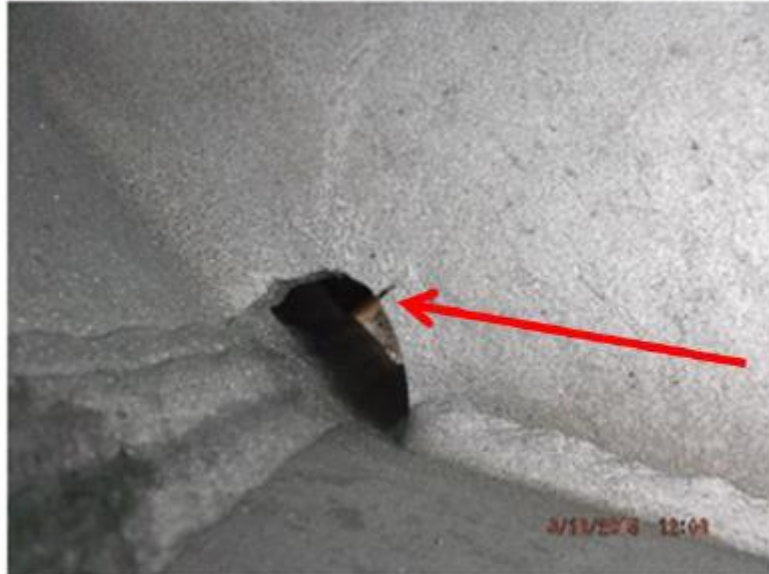
Figure 6 A crack that has initiated at a flame-cut 'snipe' intended to facilitate making a multipass weld. Cracking is due to the high local hardness and stress concentrations induced during flame cutting.

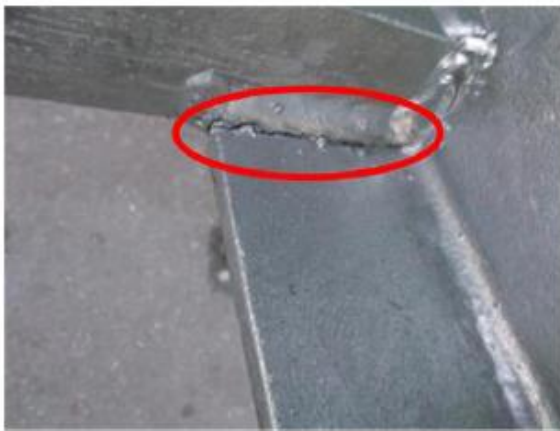
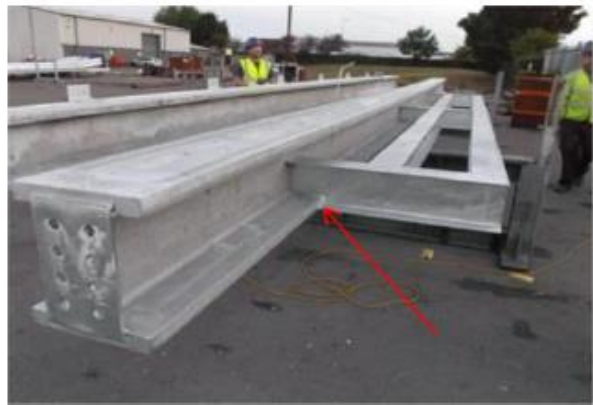
Complex welded fabrications involving the joining of plates of significantly different thickness can lead to cracking during galvanizing because of the differential cooling rates, hardness values and stress concentrations associated with such joints. Figure 7 shows one such example where discussions between the fabricator and the galvanizer would have enabled a minor change to fabrication to be made, perhaps utilising bolting together of the two assemblies, and the problem would have been eliminated. Figure 8 illustrates another problem sometimes encountered during galvanizing of relatively heavy and complex welded fabrications. The square box section shown in Figure 8b has welds coincident with regions of high residual stress at high constraint corners. The interplay among geometric stress concentrations, hardness gradients and residual stresses can very easily either initiate micro-cracks that extend during galvanizing, or initiate LMAC in the galvanizing bath (Figure 8c). Possible design changes that could be implemented to avoid this problem include the use of hot formed seamless tube.

Figure 7 Cracking at the highly constrained joint between a smaller sub-assembly and a large I-beam. Separate fabrication of the two components and subsequent bolting would have eliminated the problem.

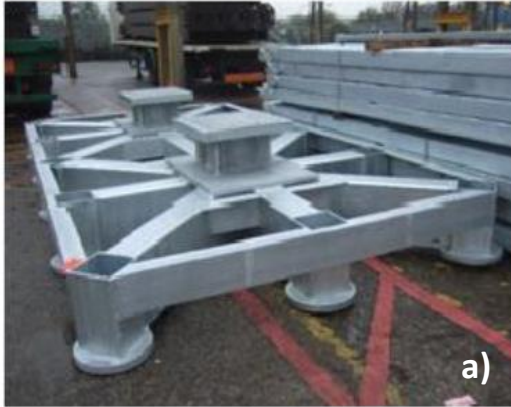
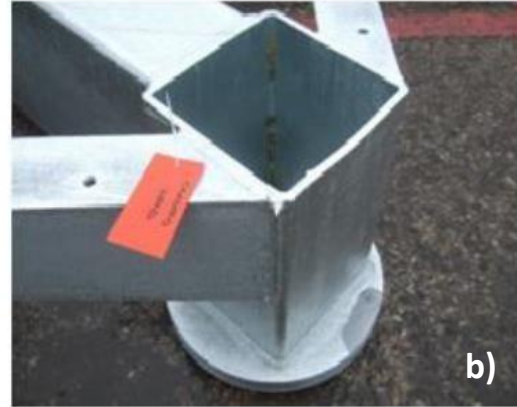
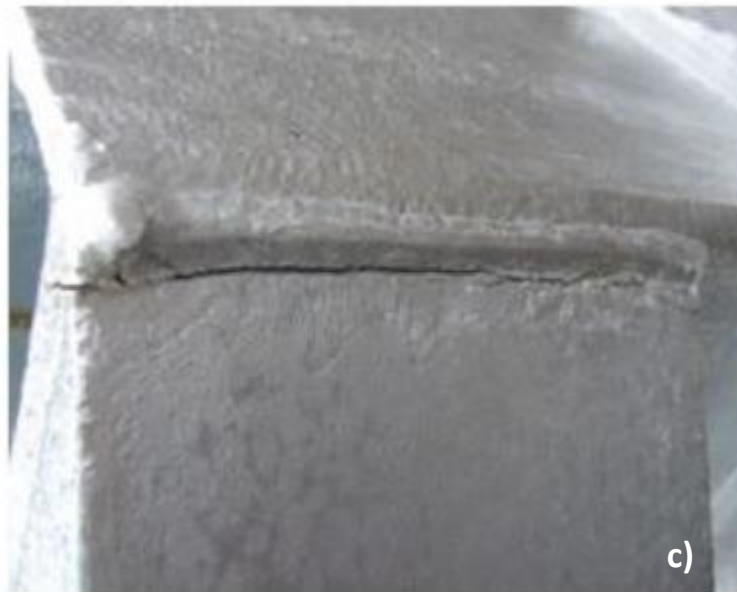
Figure 8 The complex fabrication shown in a) has square box sections b) where several welds are coincident at the highly constrained corners. The interplay among geometric stress concentrations, hardness gradients and residual stresses can very easily either initiate micro-cracks that extend during galvanizing, or initiate LMAC in the galvanizing bath

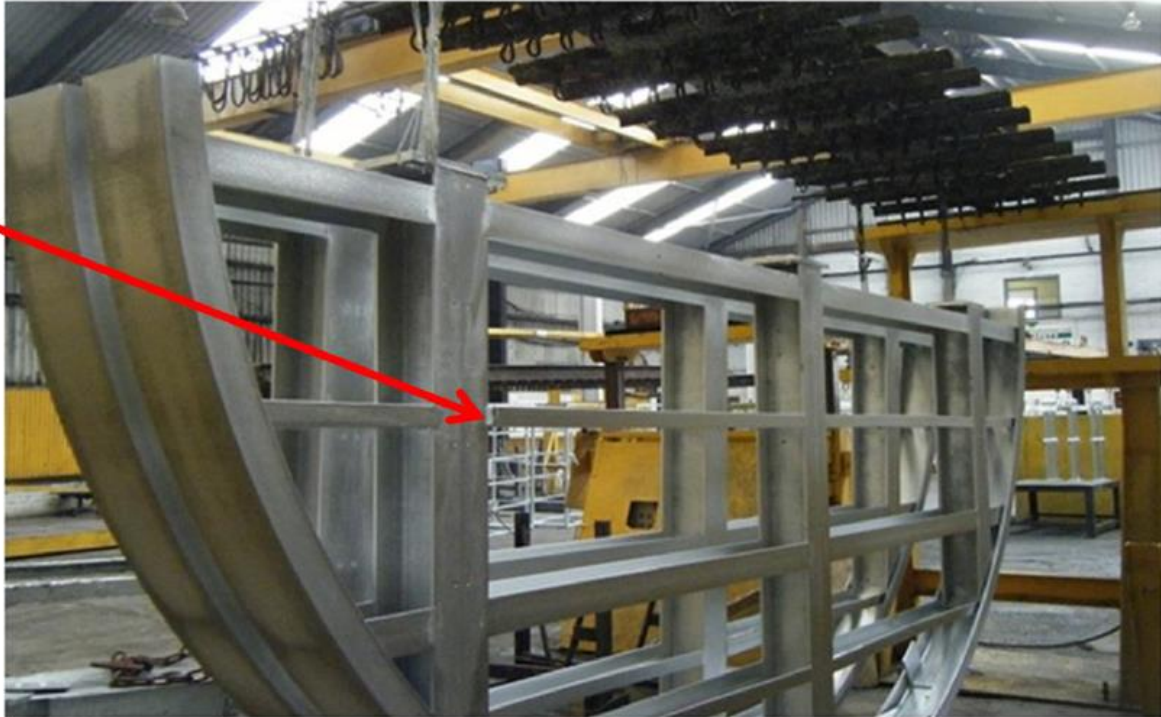
The stresses induced in highly constrained steelwork can combine with poor welding practice, such as partial penetration, to create cracking problems during galvanizing. Figure 9 shows one example of this where partial weld penetration and subsequent weld grinding have led to cracking. A number of instances of cracking arising from insufficient weld thickness as a result of weld dressing and/or partial penetration were observed in other components during this investigation into galvanizing of steelwork.

Figure 9 In this complex welded fabrication, partial weld penetration and subsequent weld grinding have led to cracking occurring during galvanizing from the under-sized weld.

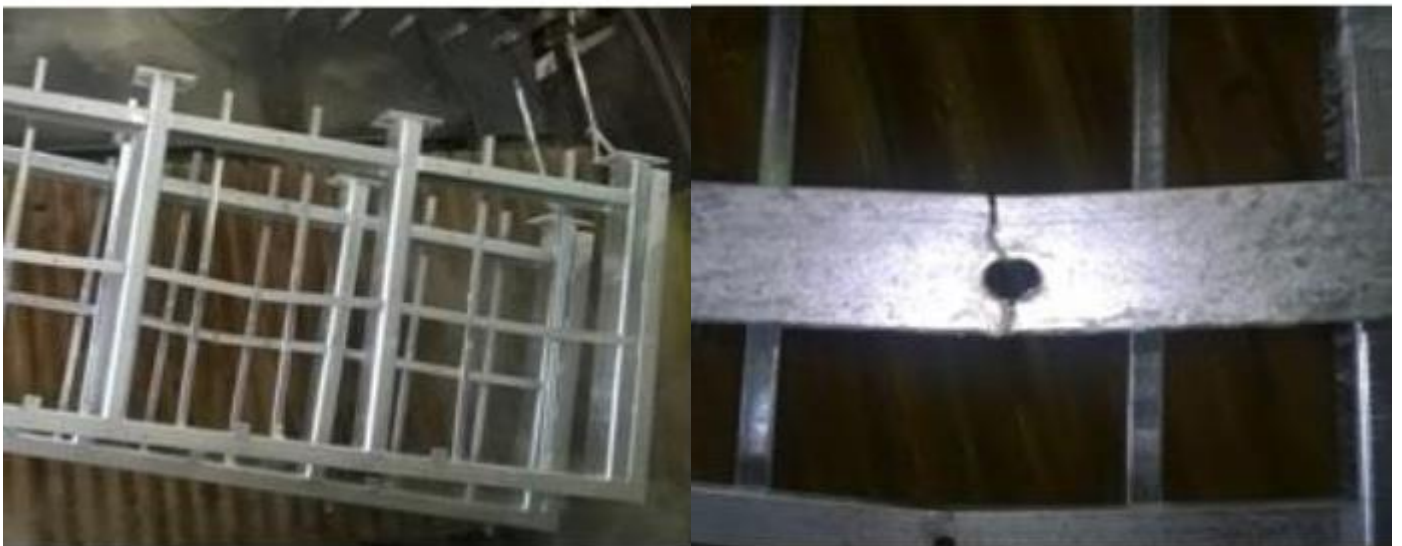
High levels of distortion-induced stresses can occur during galvanizing and an example of cracking induced by distortion is shown in Figure 10, where distortion in a smaller and highly constrained member has combined with additional stress localisation at an off-centre hole to initiate cracking. Distortion of members can also occur due to inadequate venting in steelwork intended for galvanizing. This problem is illustrated in Figure 11, where smaller and properly vented members were welded onto a larger section that was not adequately vented. Trapped internal gases have led to local bulging of the main member in the thermally-affected weld zone and hence initiated cracking at its junction with the cross-members.

Figure 10 Significant distortion has occurred in the highly constrained smaller cross-members in this steel fabrication, and the off-centre hole has led to an additional localisation of stress, causing cracking to occur during galvanizing.

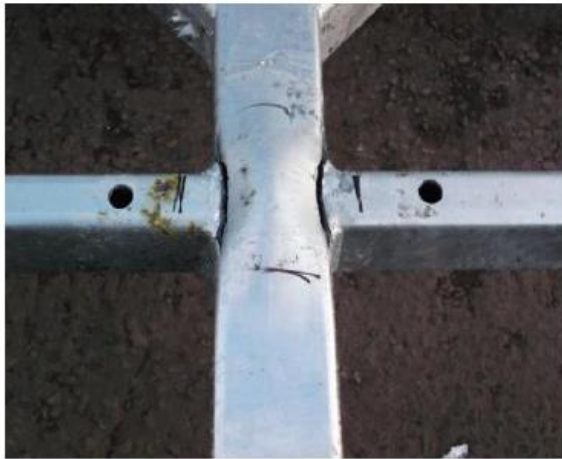
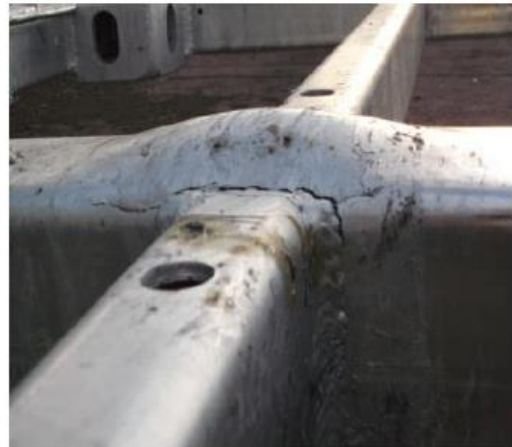
Figure 11 Inadequate venting provision has led to bulging of the main member in the thermally weakened zone where the cross-members were welded to it, causing cracking.

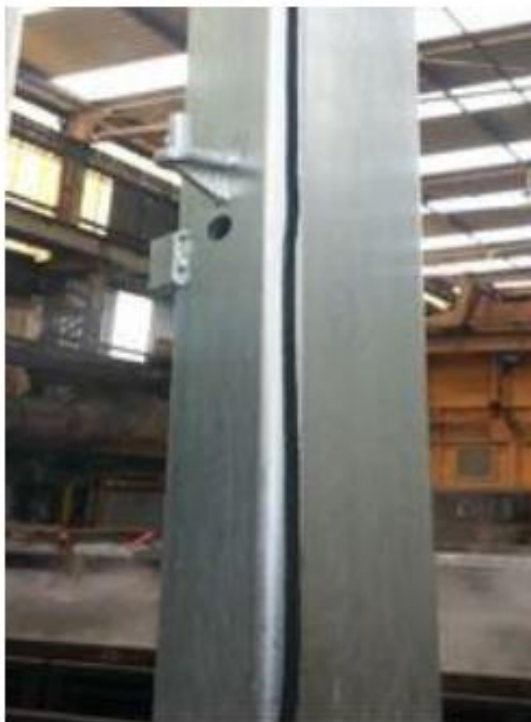
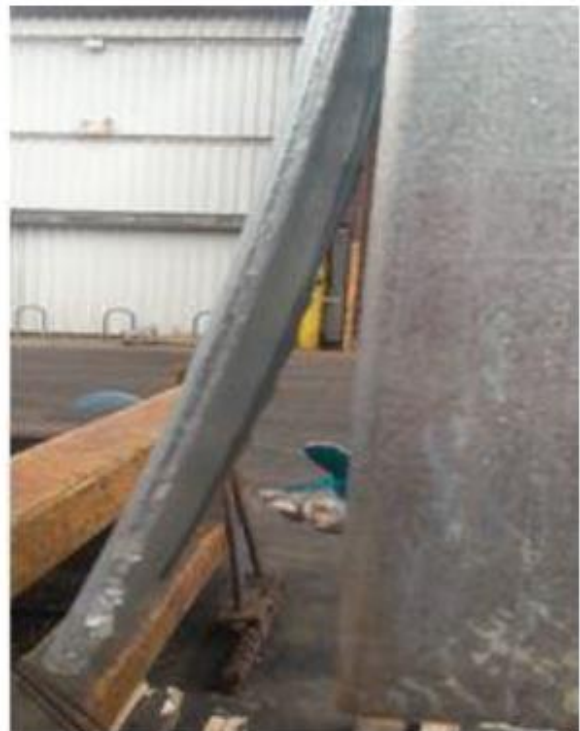
As a final example of the range of problems sometimes experienced during galvanizing, Figure 12 shows cracking in a cold formed rectangular hollow section. The residual stresses induced in either cold-rolled or welded hollow sections at the corners, tend to increase with increase in length of the component. Cracking can initiate or extend during galvanizing from either small defects at the weld ends or local stress concentrations/hard spots at flame cut edges. The high levels of tensile residual stress that existed in the outer surface are evidenced in the deformation seen in the plate after cracking.

Figure 12 Cracking in a cold formed steel section that has initiated from one end due to the high levels of residual stresses existing in the cold formed section at the corners.
